## THERMOGRAPHY ON ROTORBLADES

### Active thermography: Detection of wrinkles

#### Fraunhofer Institute for Wood Research Wilhelm-Klauditz-Institut WKI

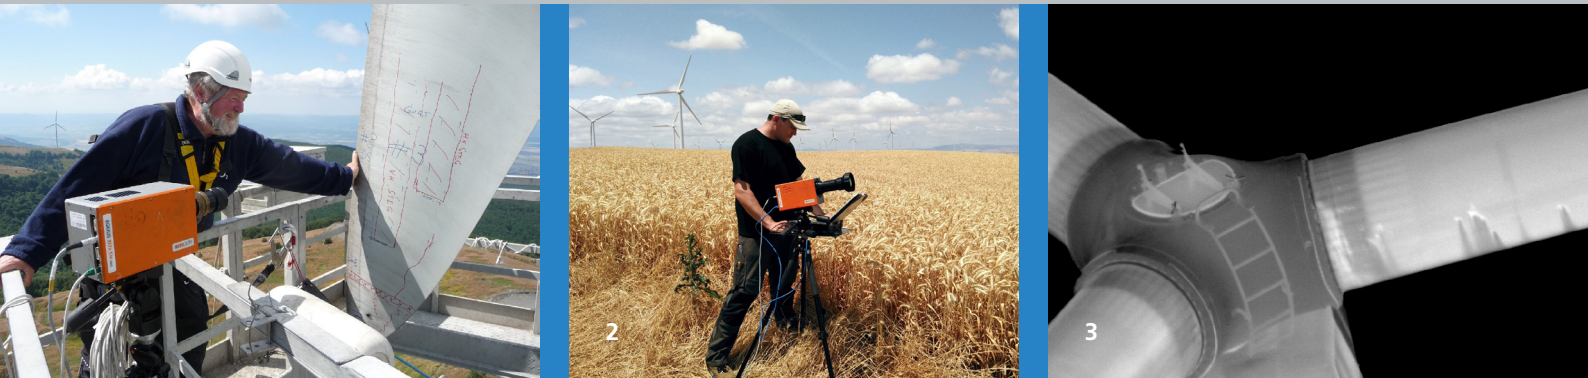
- 1 Rotorblade with inspection platform and inspection system.
- 2 Rotorblade inspection from the ground on the spinning blades.
- 3 Detected defects near the flange.

An active thermographic inspection system was developed to find even small invisible wrinkles. Repairs are possible in an early stage avoiding expensive replacements of broken blades.

With our passive thermographic inspection system it is possible to detect heavy loads near the flange or performance losses because of vortex generators placed at the wrong position. Moreover it allows the detection of the transition line and of vortex structures to learn more about the aerodynamic behavior of the used blades.
